The Town of Hillsborough

Adron F. Thompson Water/Sewer Facility: Feasibility Study

Utilities Department

10.04.2019

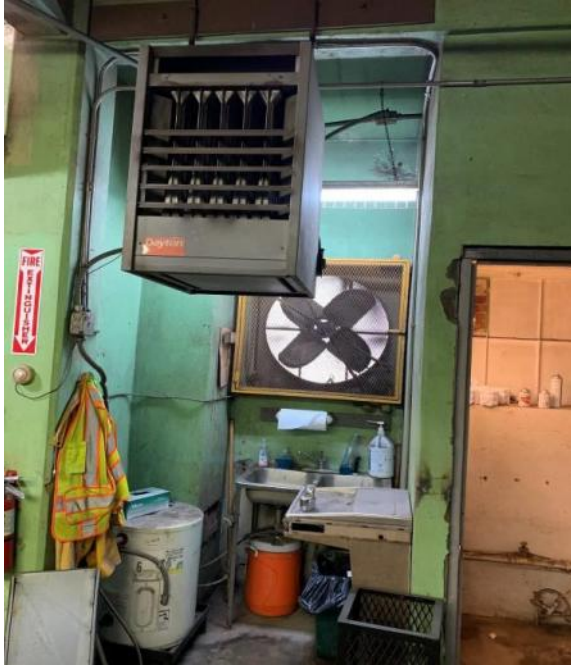
Main Building (Original) –Basement:

- Heat: Propane fired unit heaters.
- Cooling: Through wall ventilation fan.
- Toilet Exhaust: Natural

- ADA Compliant: No (toilet, water cooler, utility sink).
- Water Heater: 2,000W Electric
- Gas Piping: Copper, exposed.
- Propane, forced air unit heater.
- Waste and Vent Piping: Cast Iron exposed.
- Water Piping: Copper Exposed

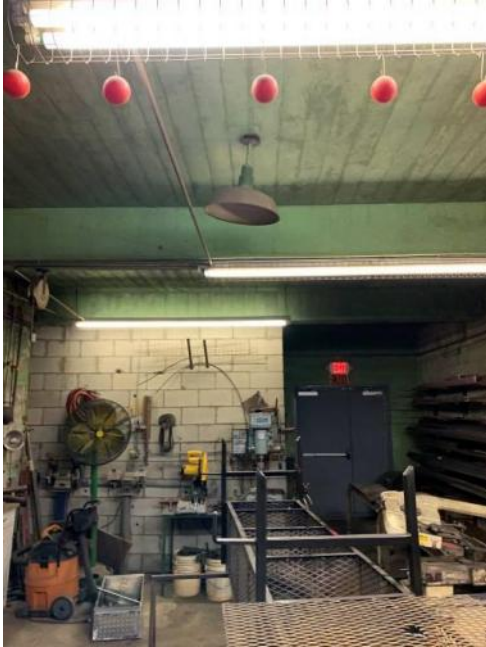
Main Building (Original) –Basement:

- Combination of obsolete incandescent and fluorescent (T12) fixtures.
- Miscellaneous Power: Wall mounted receptacles and cord reel for shop equipment and tools
- Wiring Methods: Assortment of surface mounted rigid metal conduit, EMT, flexible conduit and MC Cable.
- Emergency Lighting: One combination emergency / exit fixture. Additional emergency lighting needed.

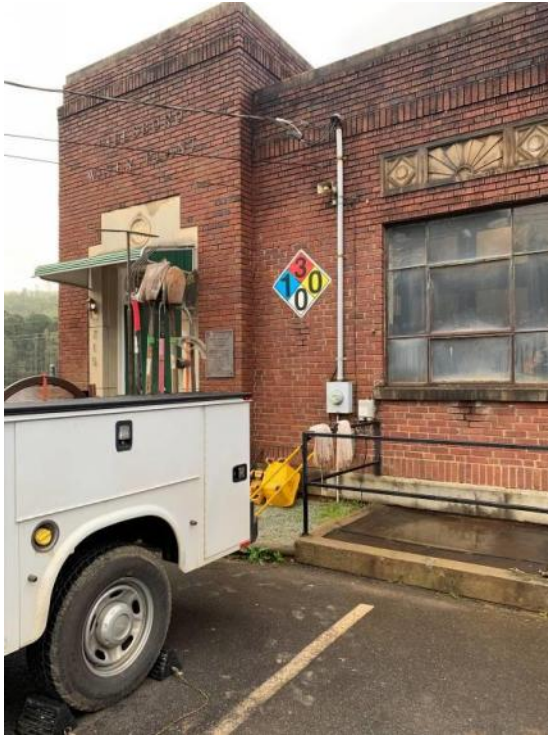
Main Building (Original) – Upper Level:

- Overhead drop from Duke Energy Power Pole.
- 120/240V, 200A, 1-Phase Service
- Power Meter mounted on front of building near main entrance.
- 30kW Kohler generator with diesel base tank.
- Service Entrance Panel surface mounted near main entrance.
- 100A Generator feed directly into panelboard. Generator breaker is locked out but not interlocked with the main utility service breaker. This arrangement is not code compliant and should be corrected in the renovation.
- Wiring Methods: Assortment of surface mounted rigid metal conduit, EMT, PVC and MC Cable.
- Feeds addition (60A)

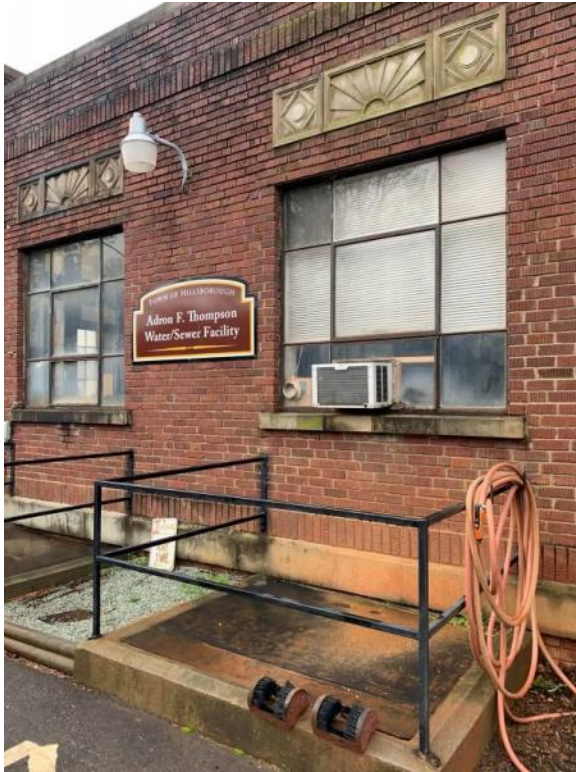
Main Building (Original) – Upper Level:

- Combination of obsolete incandescent and fluorescent (T12) fixtures.
- Emergency Lighting: One combination emergency / exit fixture. Additional emergency lighting needed.
- 50A Load Center recessed in wall in office does not have code minimum clear work space.
- Exterior emergency Egress Lighting: None.
- Building has no fire alarm system.

HVAC: Minimal - Window unit for front office and ducted supply from addition for side office.

Plumbing: None

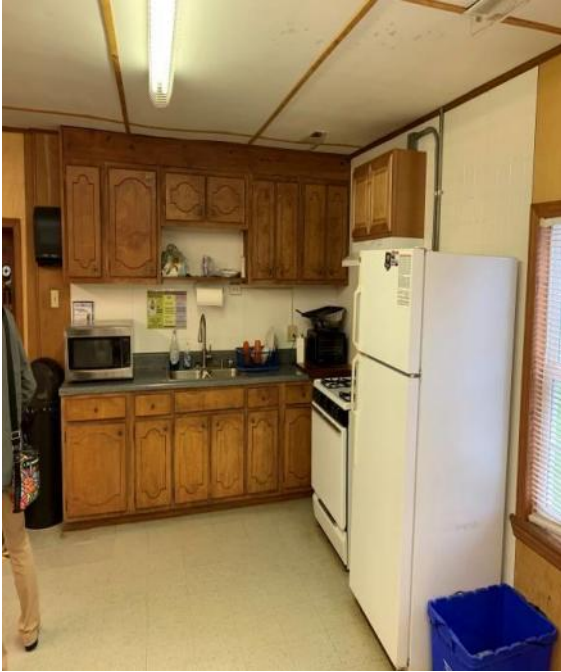
Main Building (Addition) – Upper Level:

- Break Area with Sink
- Toilet with shower.
- Washer and dryer in toilet.

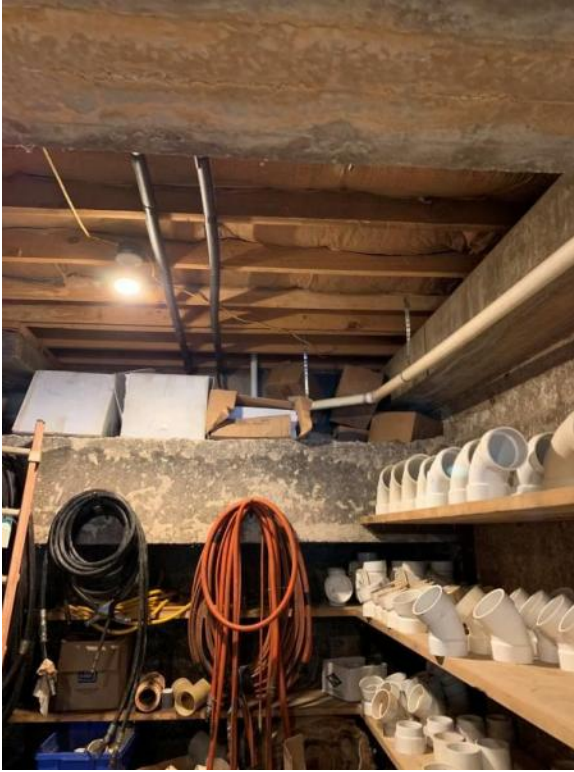
Main Building (Addition) – Upper Level:

- Piping exposed is unconditioned storage area below.
- Water Heater in Break / Multi-purpose room with screen wall enclosure.
- Ice Machine in Break / Multi-purpose room.

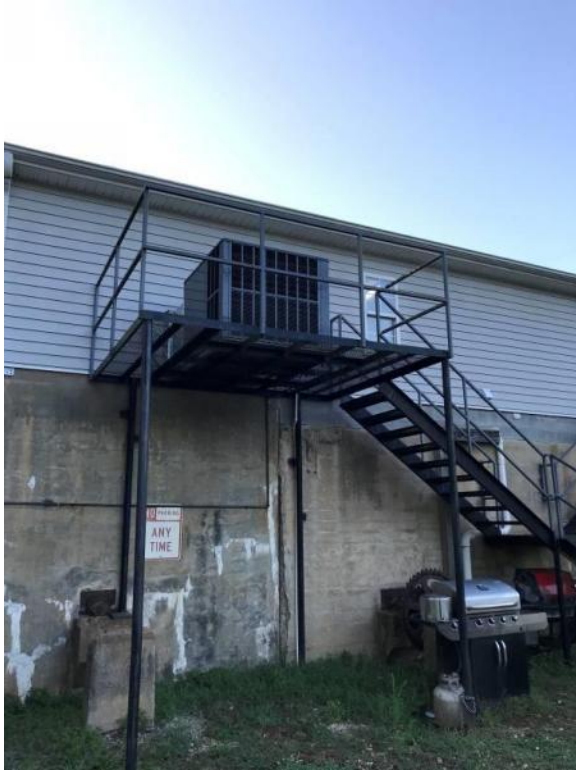
Main Building (Addition) – Upper Level:

- 5-Ton Package Unit with electric cooling and propane heating (100,000BTU/HR).
- Unit service addition and small adjacent office in original building.
- Stand alone toilet exhaust / light combo.
- Side wall dryer vent
- Residential recirculating range hood.

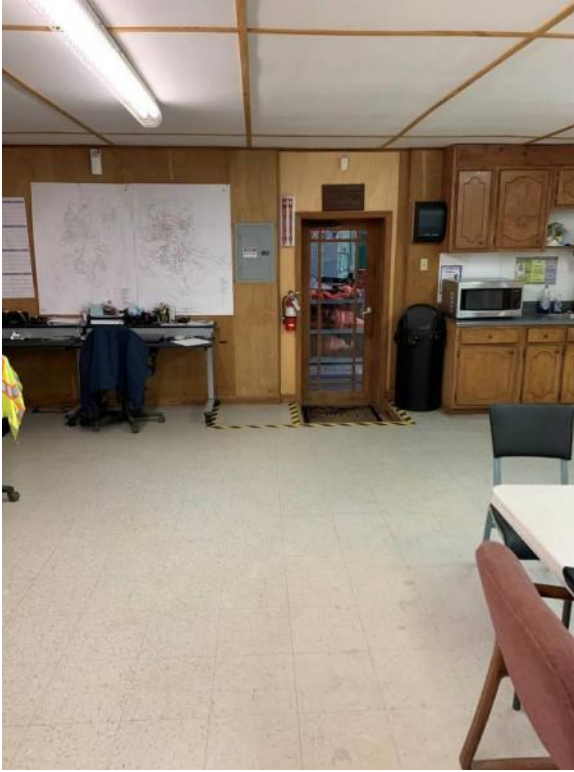
Main Building (Addition) – Upper Level:

- 120/240V, 60A subpanel fed from main service panel in original building
- Obsolete Fluorescent Lighting
- Only one exit path marked.
- Insufficient emergency lighting
- No exterior egress emergency lighting.

- f. Battery backed up emergency fixtures are recommended. Emergency lighting needs to be installed inside and outside to bring the building into compliance with current life safety codes.

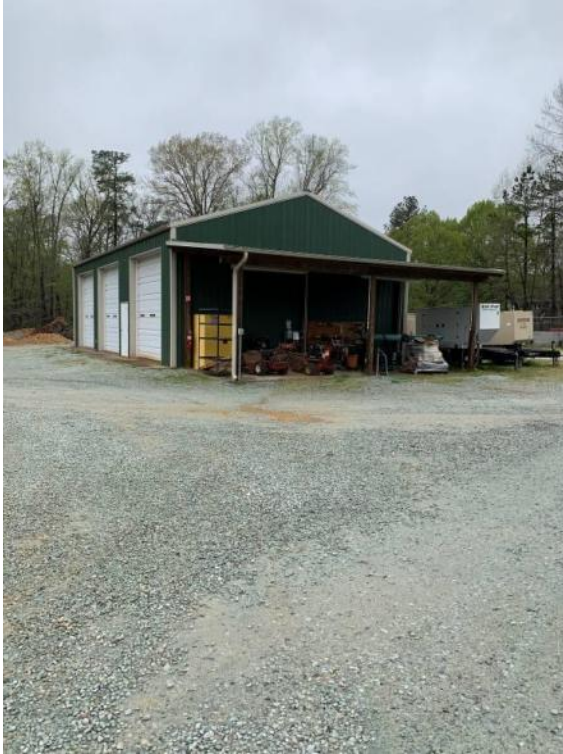
Auxiliary Building:

- No water service inside building
- Yard hydrant on exterior at east end of building.
- Air compressor, piping and drops on exterior at east end of building.
- Fueling station emergency shut off.

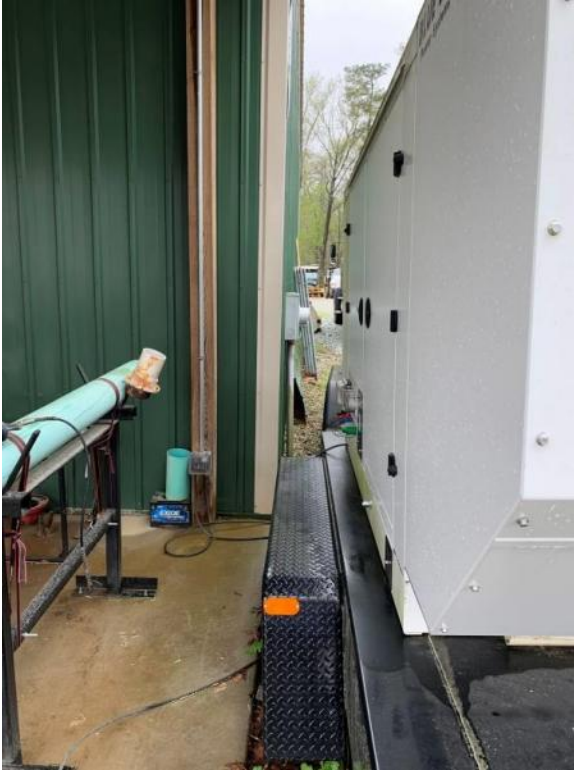
Auxiliary Building:

- Minimal Heat Only. One small electric unit heater.

- Duke Energy 120/240V, 200A, Single-Phase electrical service.
- Service Entrance routed under ground pole line to building meter.
- Meter installed on north side of building (east end).
- 200A Load Center installed inside building directly behind meter.
- Convenience Receptacles installed on East end of building under shed roof.
- Fluorescent gasketed fixtures installed on East end of building under shed roof.

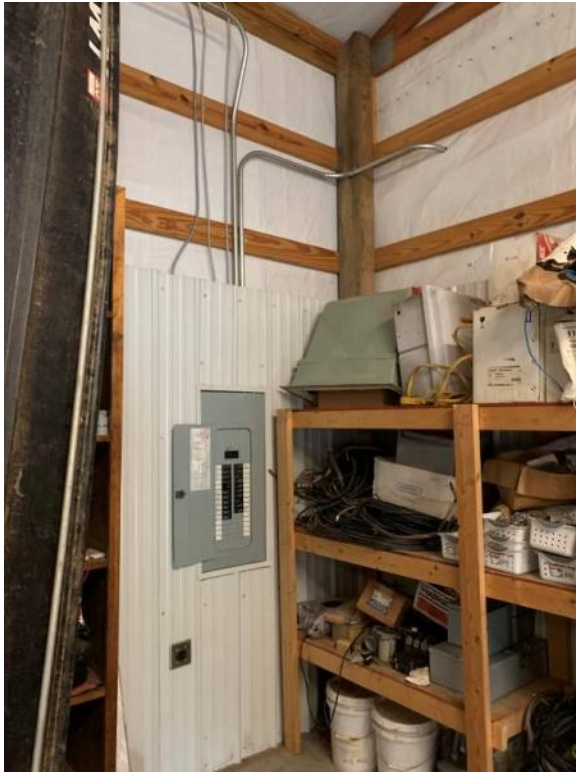
Auxiliary Building:

- 200A Load Center installed inside building directly behind meter in north east corner.
- Open lamp fluorescent shop lights
- Power: Receptacles installed along walls, Cord reels installed overhead.

- Minimal Heat Only. One small ceiling mounted unit heater.

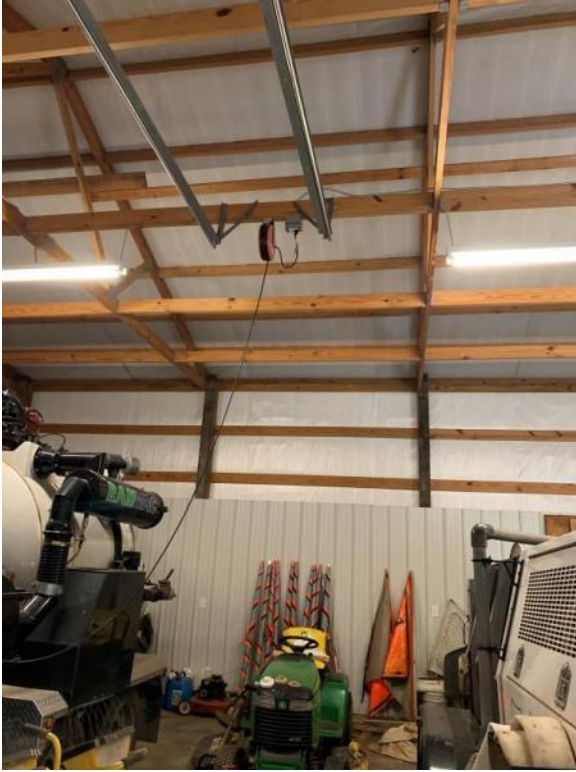
Auxiliary Building:

- 200A Load Center installed inside building directly behind meter in north east corner.
- Open lamp fluorescent shop lights
- Power: Receptacles installed along walls, Cord reels installed overhead.
- Power: Receptacles installed on exterior of building on West end.
- Area light installed on West end of building. No other exterior building mounted lights. No exterior emergency egress lighting.

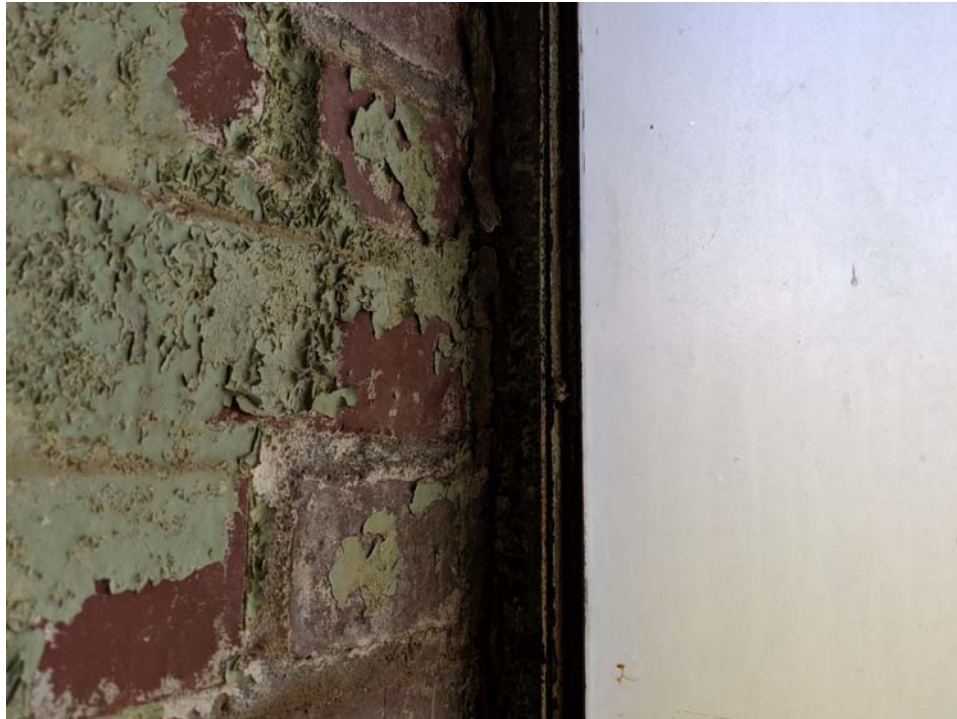
Asbestos containing window caulk between window sash and brick.

Matrix recommends these materials and equipment be properly abated or removed and legally disposed of as part of any renovation to the Adron F. Thompson facility.

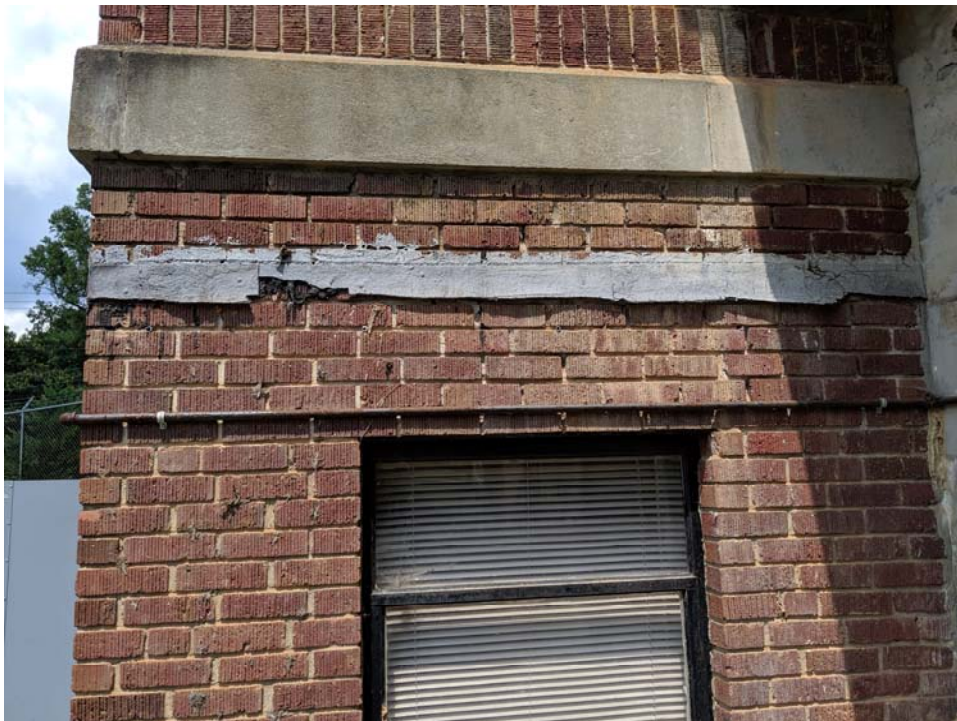
Asbestos containing flashing on C Side.

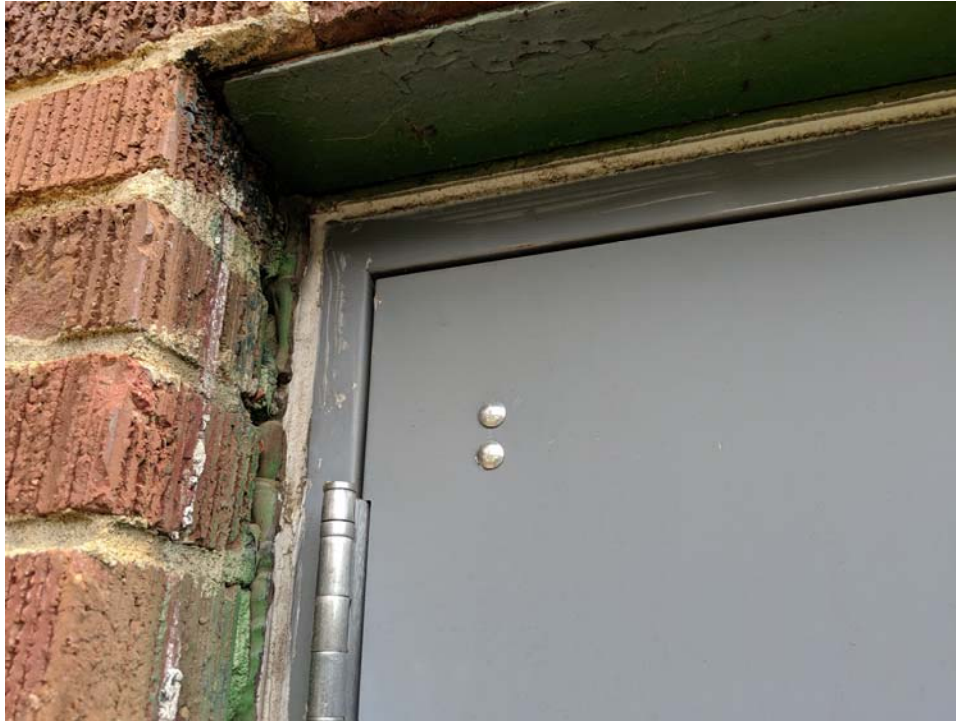
Door caulk on original brick structure.
