The Town of Hillsborough

Adron F. Thompson Water/Sewer Facility: Feasibility Study

Utilities Department

10.04.2019

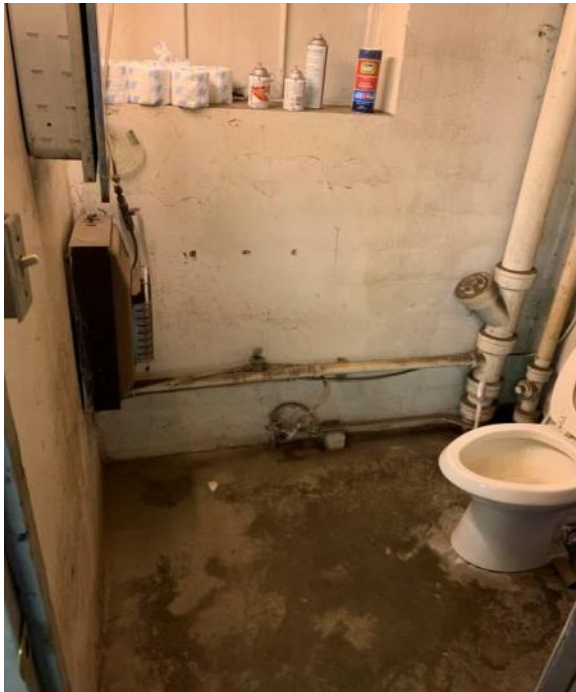
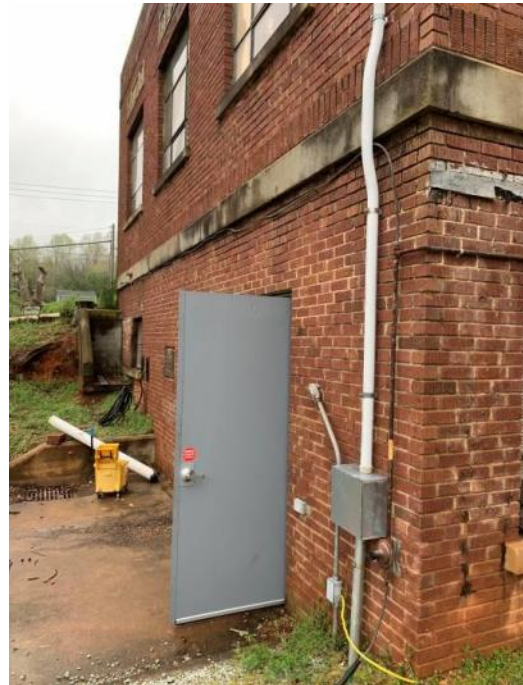
Main Building (Original) –Basement:

Plumbing:

- ADA Compliant: No (toilet, water cooler, utility sink).
- Water Heater: 2,000W Electric
- Gas Piping: Copper, exposed.
- Propane, forced air unit heater.
- Waste and Vent Piping: Cast Iron exposed.
- Water Piping: Copper Exposed

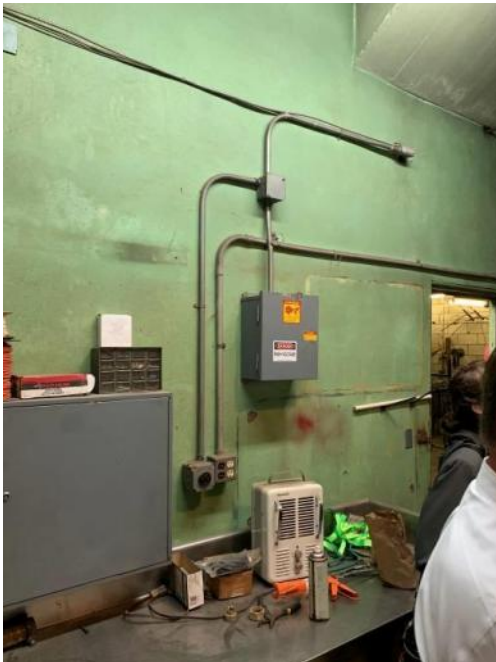
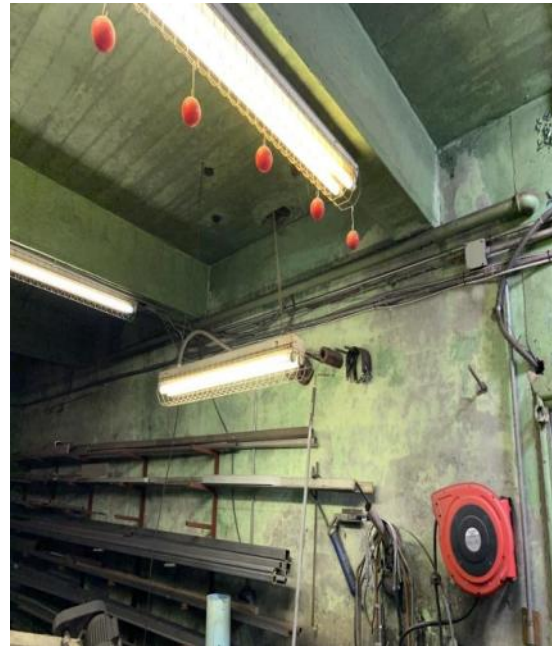
Main Building (Original) – Upper Level:

Electrical:

- Combination of obsolete incandescent and fluorescent (T12) fixtures.
- Miscellaneous Power: Wall mounted receptacles and cord reel for shop equipment and tools
- Wiring Methods: Assortment of surface mounted rigid metal conduit, EMT, flexible conduit and MC Cable.
- Emergency Lighting: One combination emergency / exit fixture. Additional emergency lighting needed.

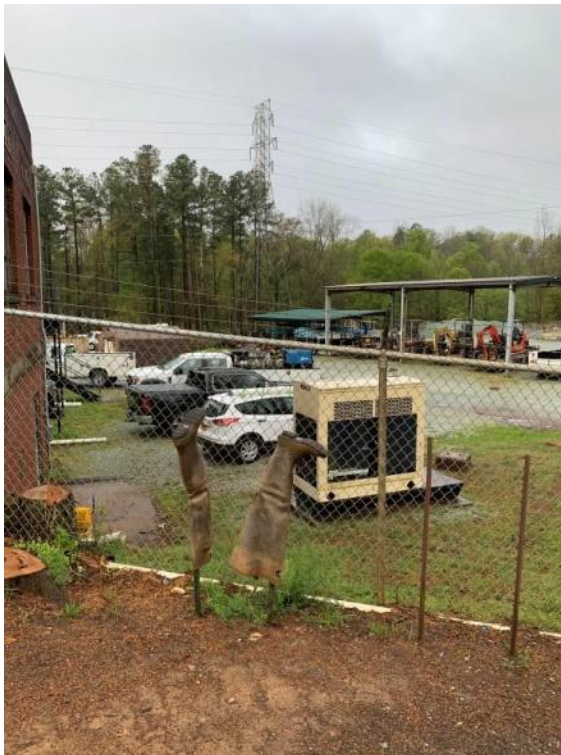
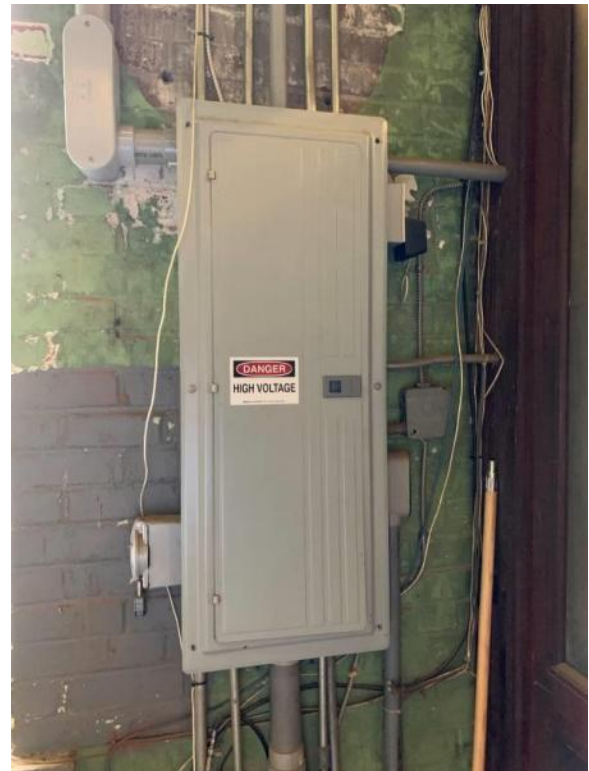
Main Building (Original) – Upper Level:

Electrical:

- Overhead drop from Duke Energy Power Pole.
- 120/240V, 200A, 1-Phase Service
- Power Meter mounted on front of building near main entrance.
- 30kW Kohler generator with diesel base tank.
- Service Entrance Panel surface mounted near main entrance.
- 100A Generator feed directly into panelboard. Generator breaker is locked out but not interlocked with the main utility service breaker. This arrangement is not code compliant and should be corrected in the renovation.
- Wiring Methods: Assortment of surface mounted rigid metal conduit, EMT, PVC and MC Cable.
- Feeds addition (60A)

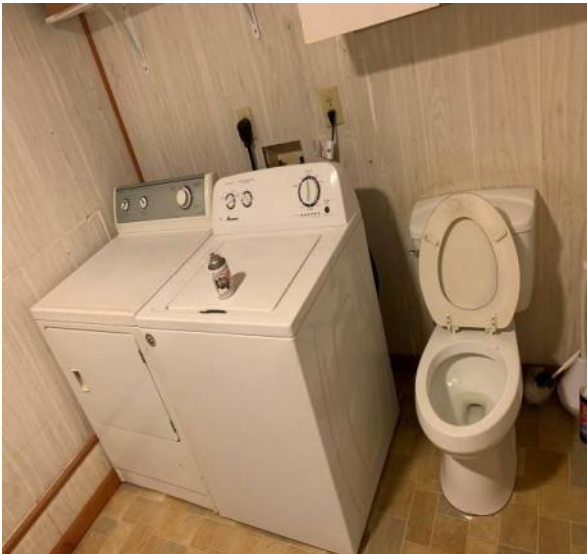
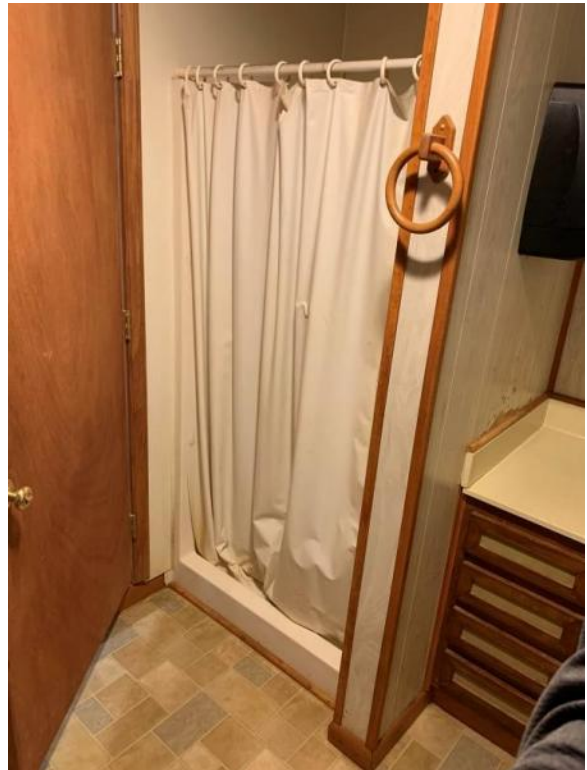
Main Building (Addition) – Upper Level:

Plumbing:

- Break Area with Sink
- Toilet with shower.
- Washer and dryer in toilet.

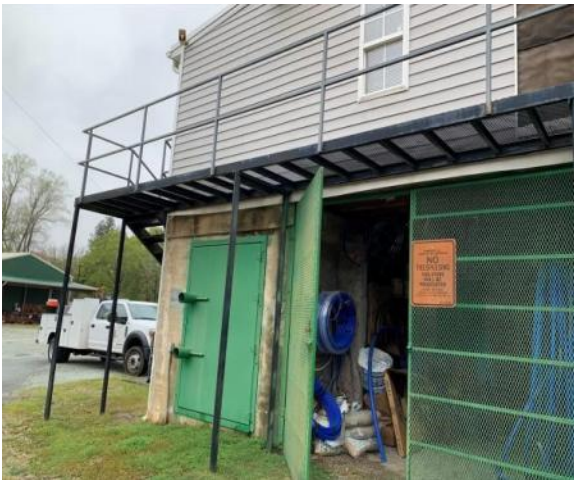
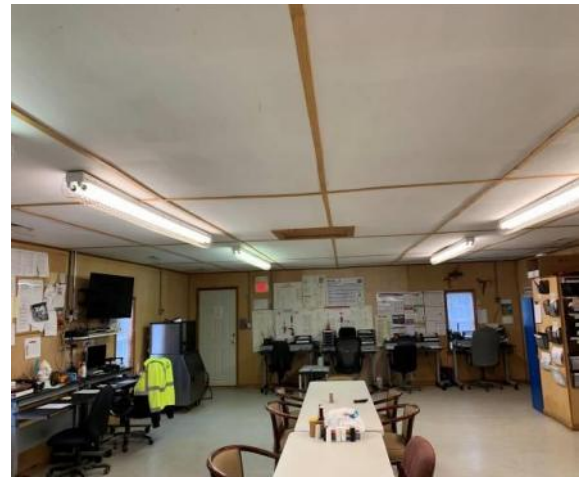
Main Building (Addition) – Upper Level:

Plumbing:

- Piping exposed is unconditioned storage area below.
- Water Heater in Break / Multi-purpose room with screen wall enclosure.
- Ice Machine in Break / Multi-purpose room.

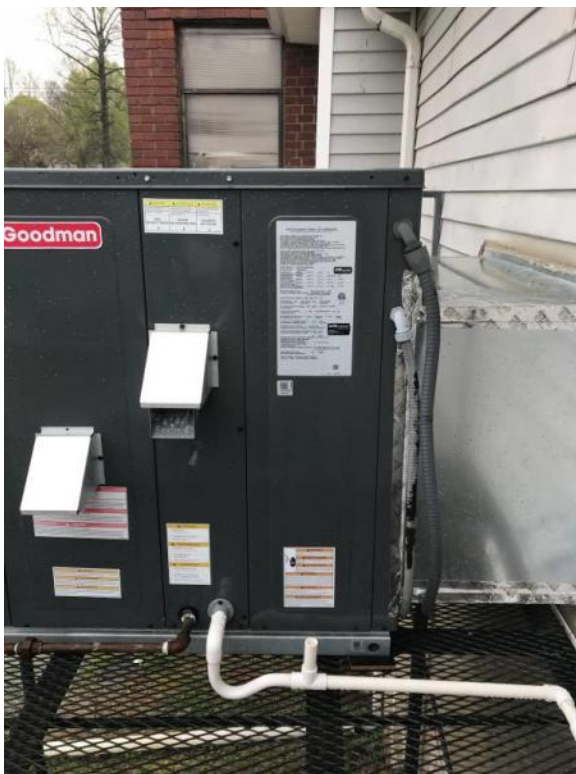
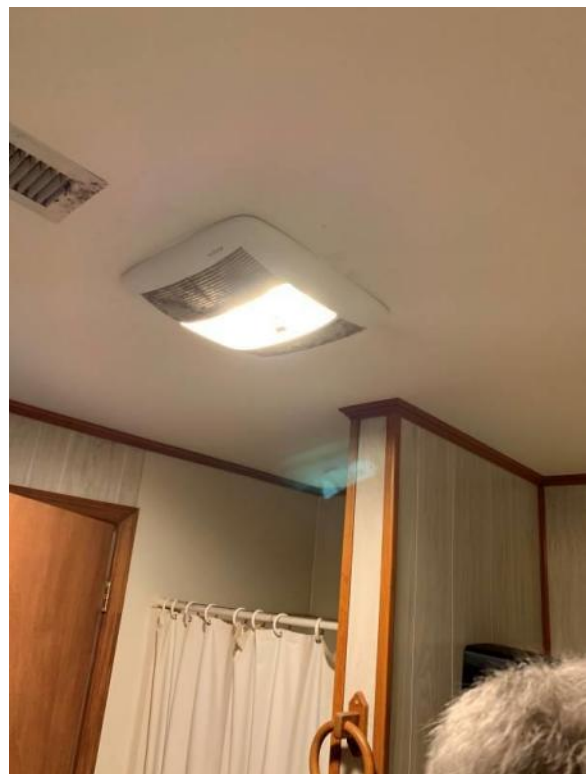
Main Building (Addition) – Upper Level:

HVAC:

- 5-Ton Package Unit with electric cooling and propane heating (100,000BTU/HR).
- Unit service addition and small adjacent office in original building.
- Stand alone toilet exhaust / light combo.
- Side wall dryer vent
- Residential recirculating range hood.

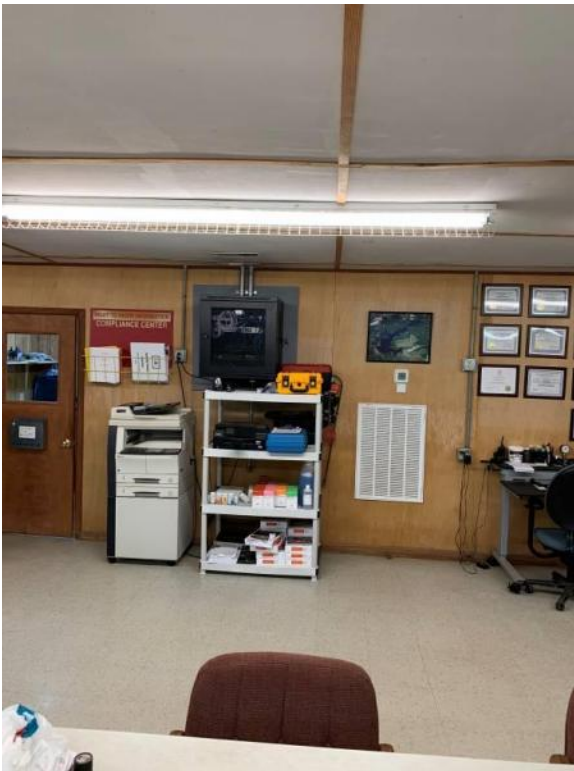
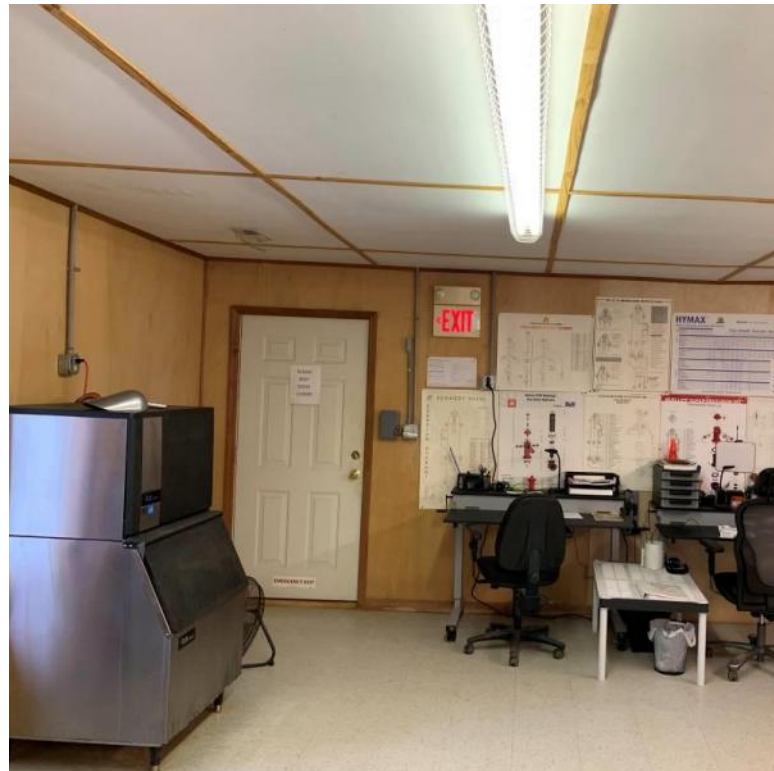
Auxiliary Building:

Electrical:

- 120/240V, 60A subpanel fed from main service panel in original building
- Obsolete Fluorescent Lighting
- Only one exit path marked.
- Insufficient emergency lighting
- No exterior egress emergency lighting.

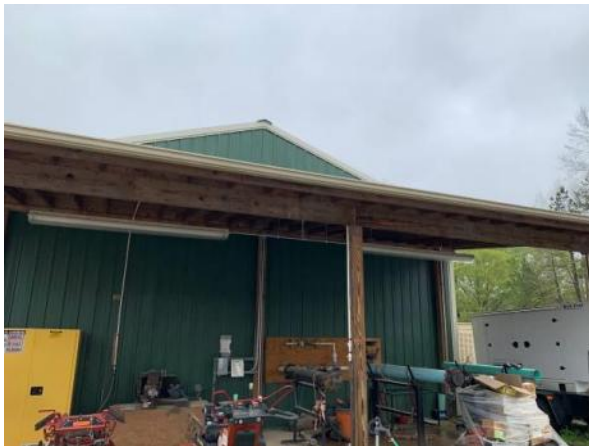
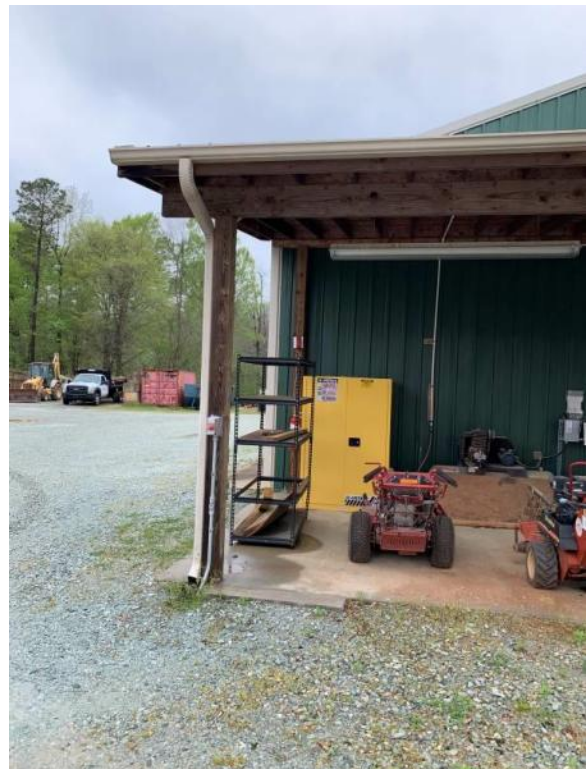
Auxiliary Building:

Plumbing:

- No water service inside building
- Yard hydrant on exterior at east end of building.
- Air compressor, piping and drops on exterior at east end of building.
- Fueling station emergency shut off.

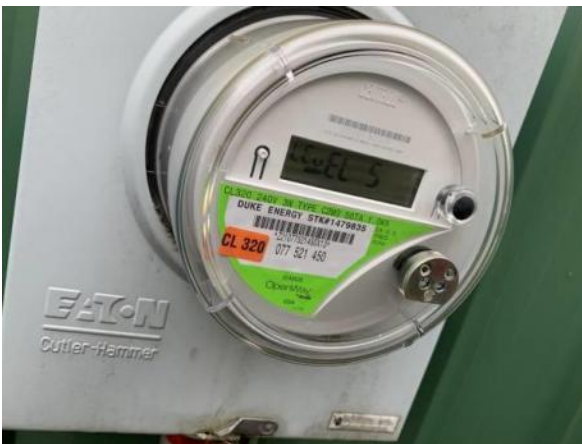
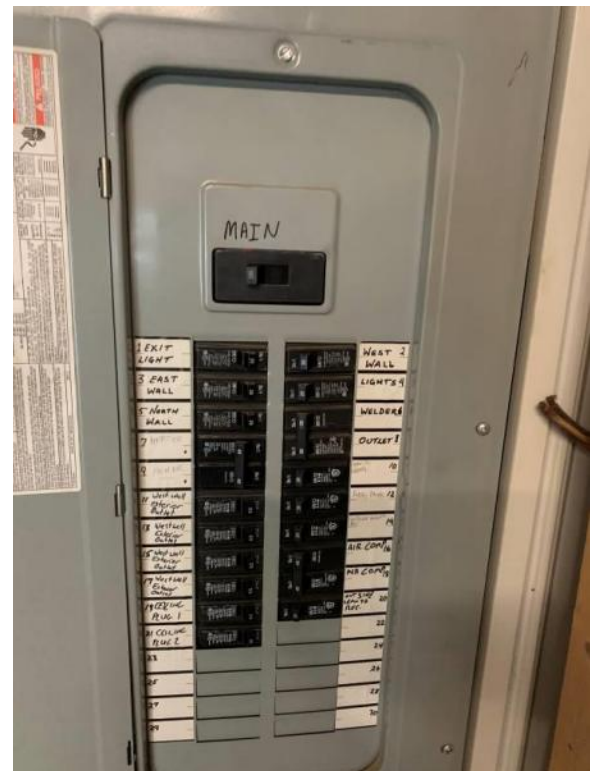
Auxiliary Building:

Electrical:

- Duke Energy 120/240V, 200A, Single-Phase electrical service.
- Service Entrance routed under ground pole line to building meter.
- Meter installed on north side of building (east end).
- 200A Load Center installed inside building directly behind meter.
- Convenience Receptacles installed on East end of building under shed roof.
- Fluorescent gasketed fixtures installed on East end of building under shed roof.

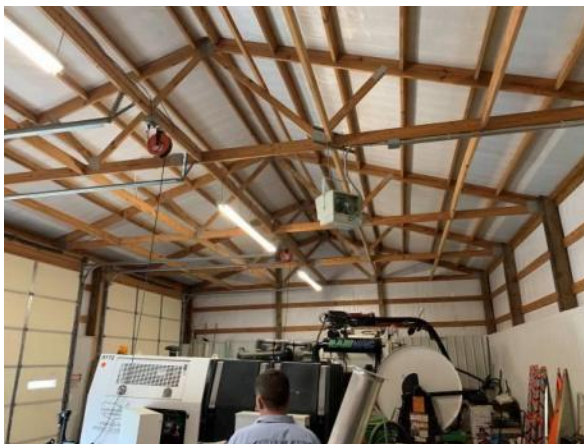
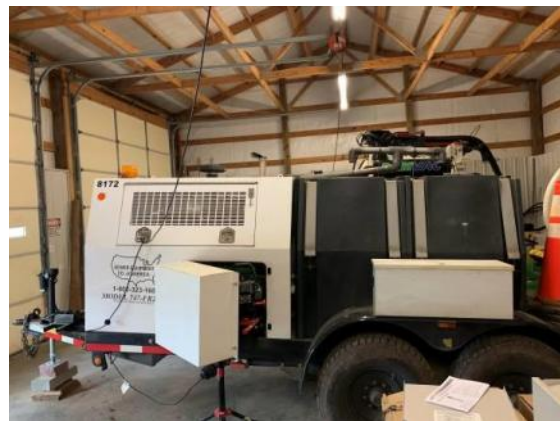
Auxiliary Building:

HVAC:

- Minimal Heat Only. One small ceiling mounted unit heater.

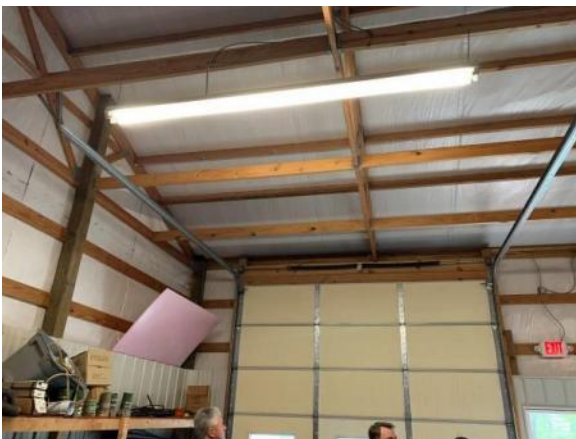
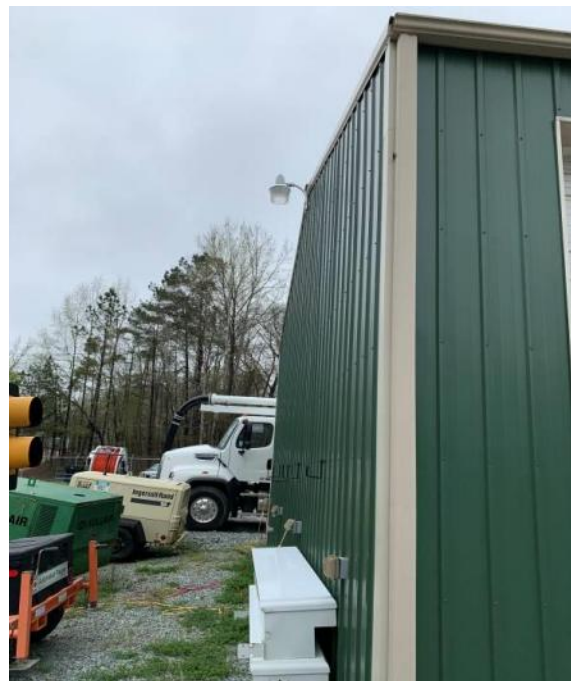
Electrical:

- 200A Load Center installed inside building directly behind meter in north east corner.
- Open lamp fluorescent shop lights
- Power: Receptacles installed along walls, Cord reels installed overhead.
- Power: Receptacles installed on exterior of building on West end.
- Area light installed on West end of building. No other exterior building mounted lights. No exterior emergency egress lighting.
